Reconnaissance Inspection: Municipality of San Juan Municipal Separate Storm Sewer System (“MS4”) Permit (PRR040036)

PRASA Puerto Nuevo Wastewater Treatment Plant Collection System (PR0021555)

Inspection Date: February 16, 2012

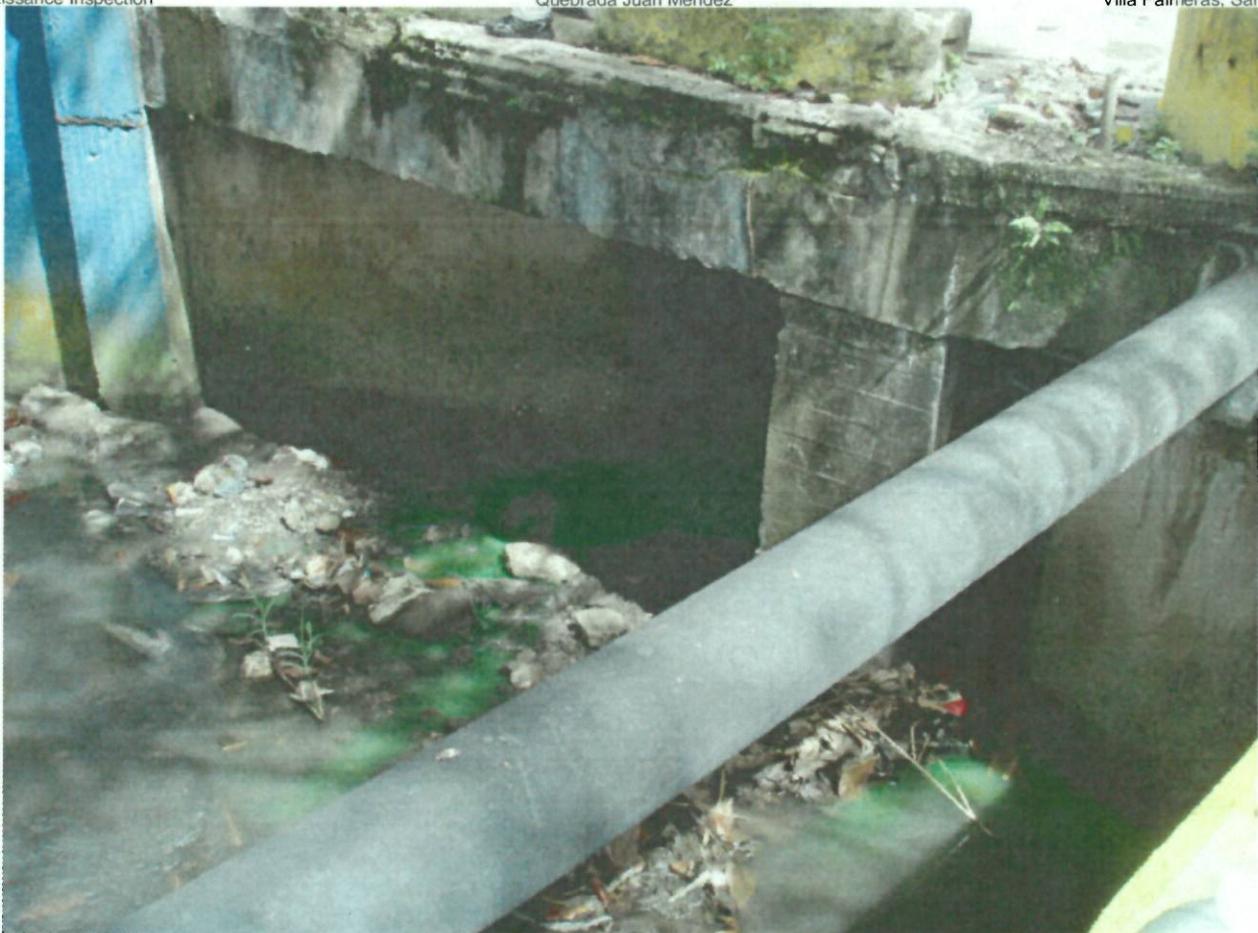
P2160234.JPG
02/16/2012

P2160234	Green dye that was placed in the sewage flow entering the stormwater catch basin is flowing out of the outfall and entering East Branch of Quebrada Juan Méndez at Calle Lealtad and José De Diego

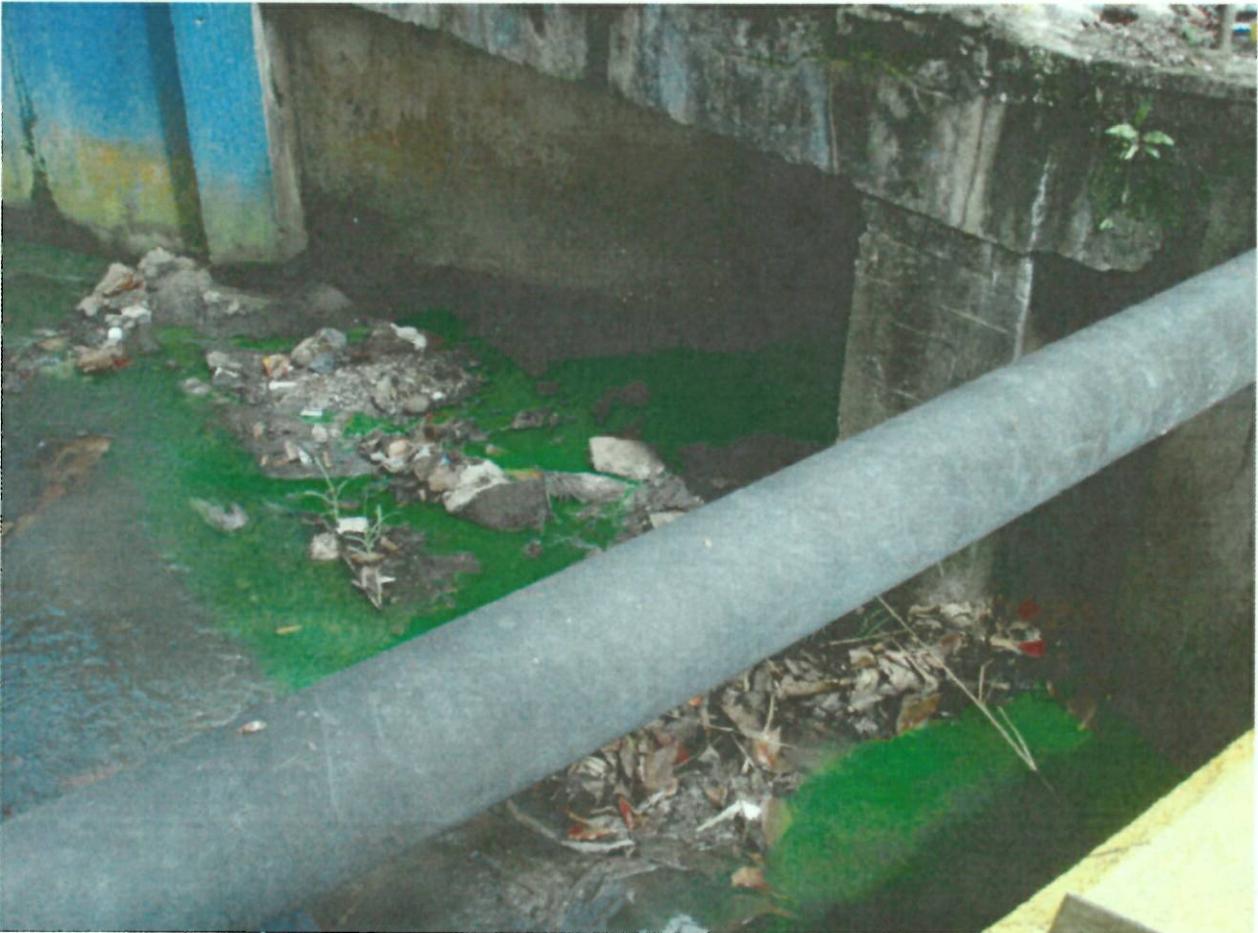
P2160235.JPG
02/16/2012

P2160235	Green dye that was placed in the sewage flow entering the stormwater catch basin is flowing out of the outfall and entering East Branch of Quebrada Juan Méndez at Calle Lealtad and José De Diego
P2160236	Dry weather flow from outfall into the west branch of Quebrada Juan Méndez seen from southwest corner of the José De Diego Ave. bridge over the west branch of Quebrada Juan Méndez
P2160237	Dry weather flow from outfall into the west branch of Quebrada Juan Méndez seen from southwest corner of the José De Diego Ave. bridge over the west branch of Quebrada Juan Méndez
P2160238	José De Diego Ave. and West Branch of Quebrada Juan Méndez
P2160239	José De Diego Ave. and West Branch of Quebrada Juan Méndez
P2160240	Calle Castro Viña (west side of street) on sidewalk on the north side of the Route 26/Baldorioty de Castro Exp. Marginal road. Manhole J6c-S008 - there was flow in the sewer and ammonia strip and pH paper was used.

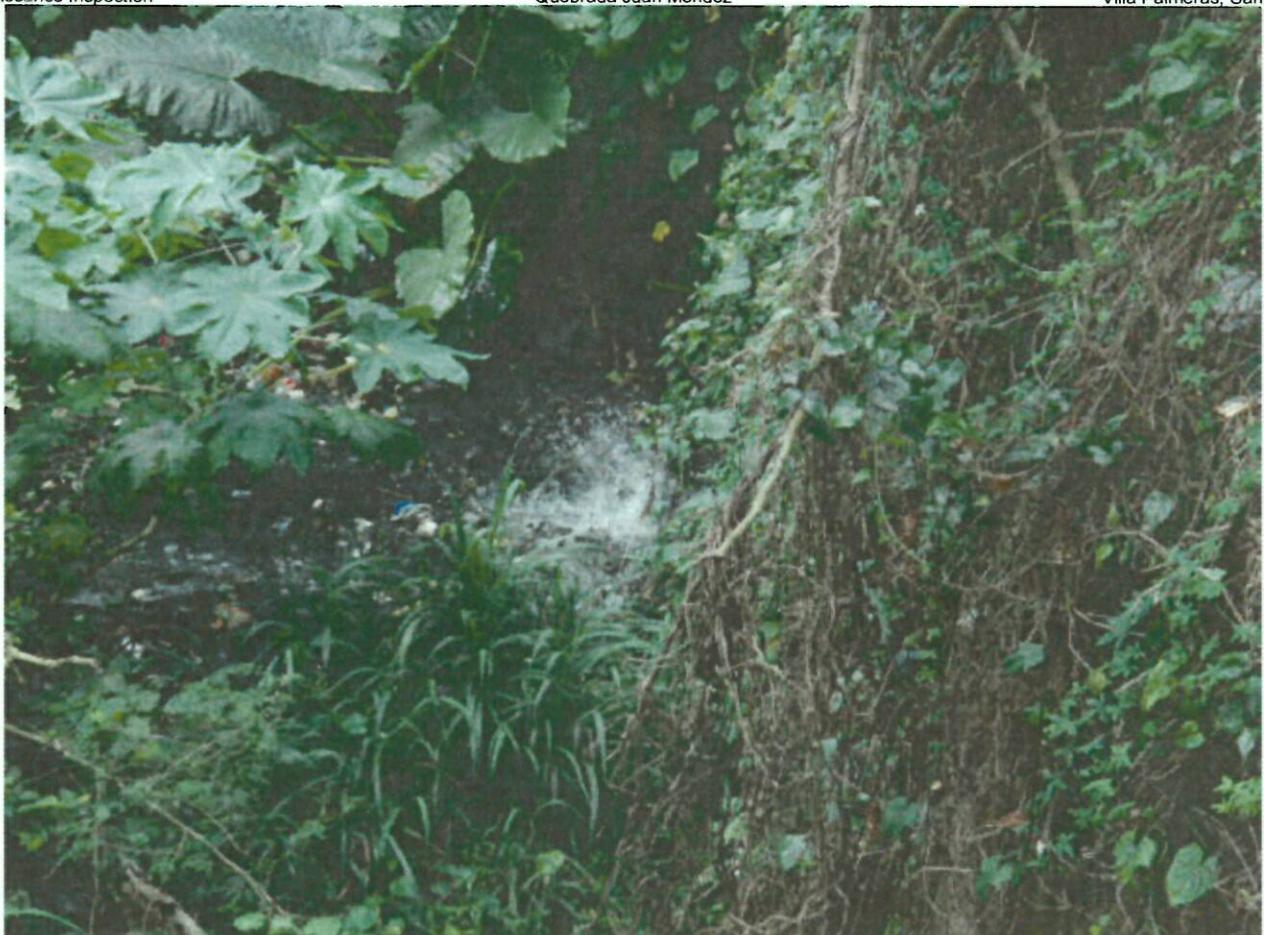
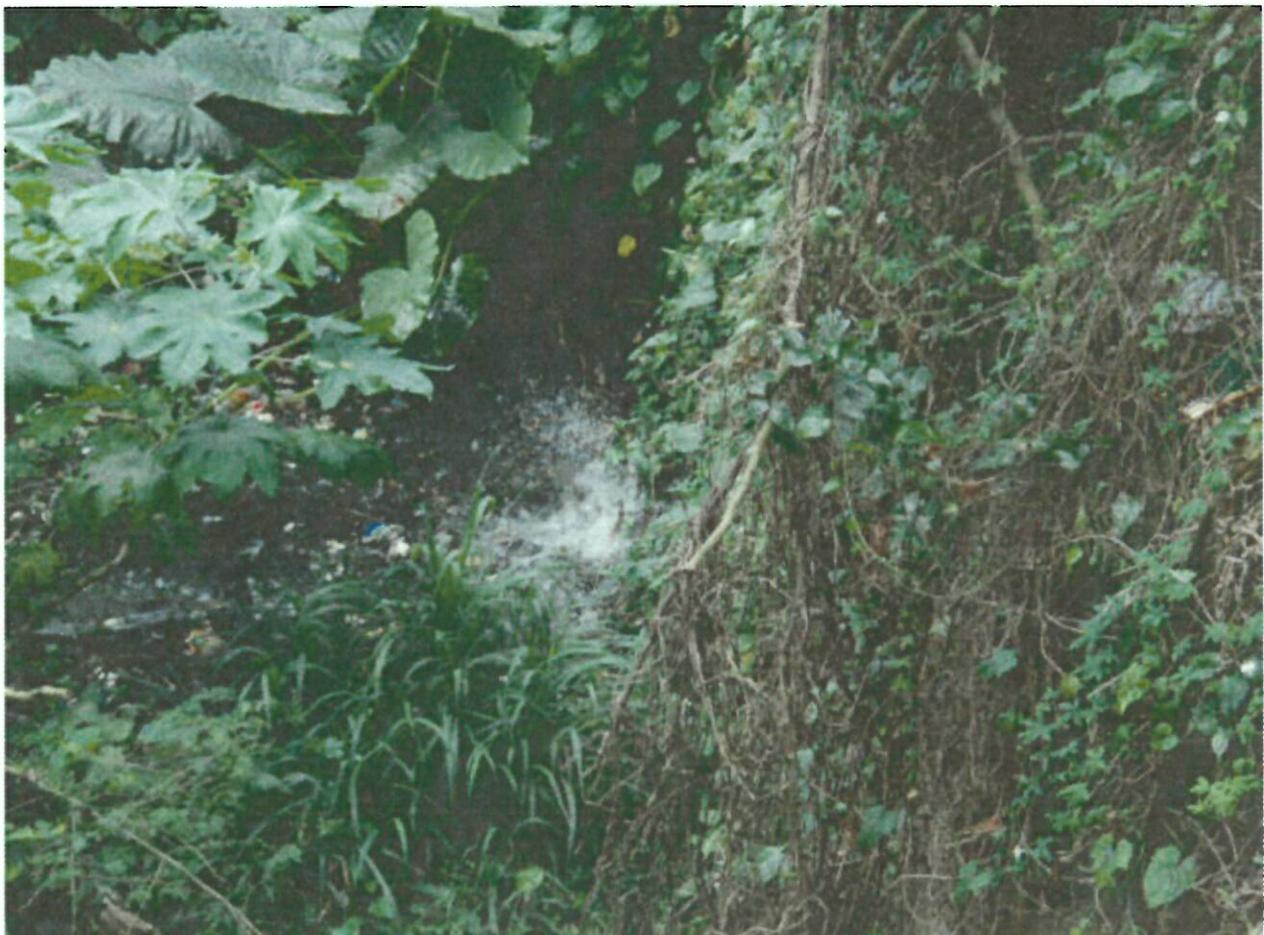
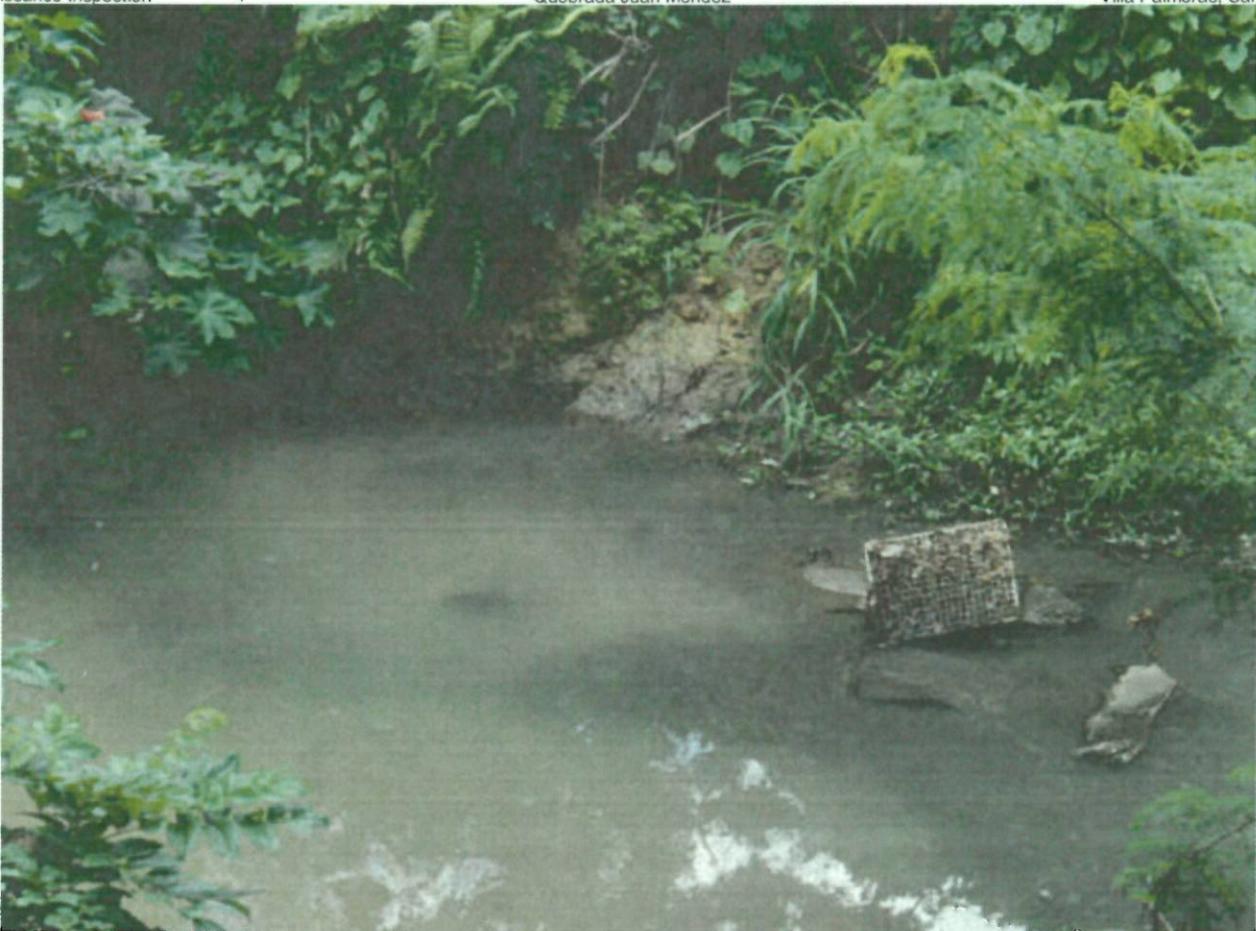
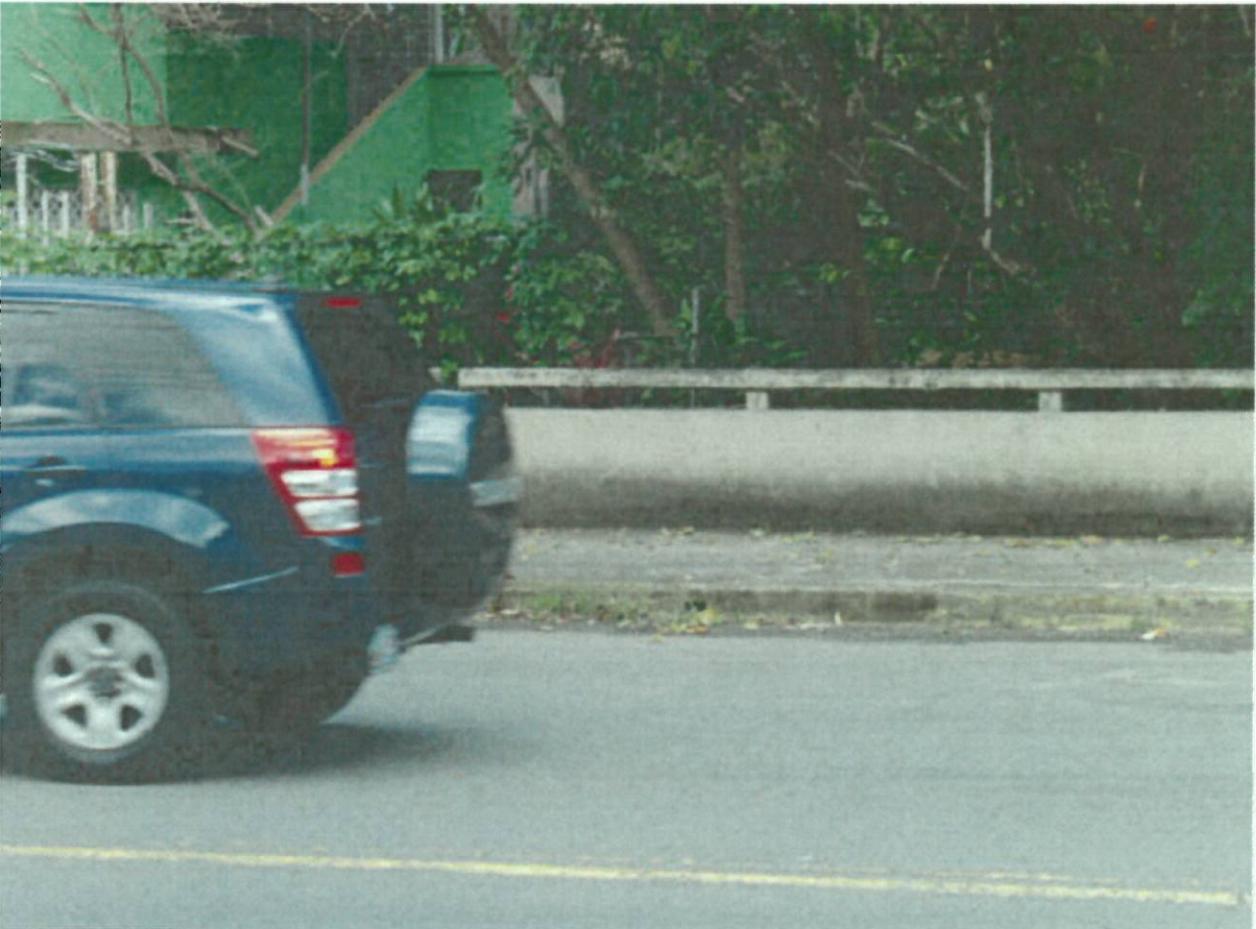
9. José De Diego Ave. (PR-47) and West Branch of Quebrada Juan Méndez (Southwest corner of bridge) – As shown in photographs 236 to 239 there was a dry weather flow entering the Quebrada Juan Méndez West Branch. (Samples were not taken) The source and characteristics of this flow should be determined and corrective actions taken as needed.
